Fiber Reinforced Polymer (FRP) Composite Bridges in West Virginia

Hota GangaRao, PE
Mark Skidmore, PE
West Virginia University
Constructed Facilities Center
February 2017

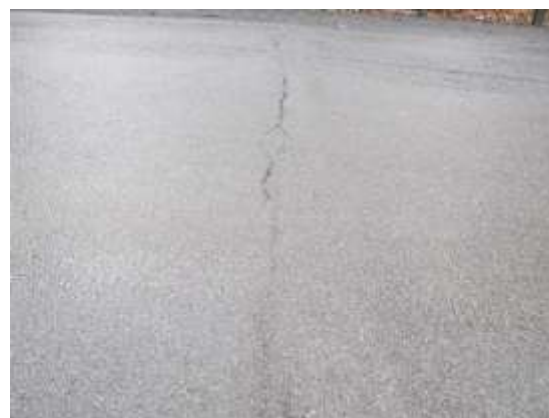
The wearing surface is in place and provides a smooth ride. Slight transverse cracking exists along both ends of the deck.

TYPICAL TRANSVERSE CRACKING

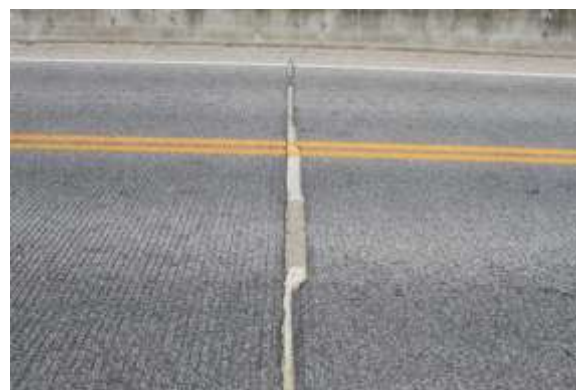
Current FRP Condition: The deck is in good condition. The decking appears to be loose in the area over the pier. The decking here rattles occasionally under live loads. The top of the deck is exposed in scattered locations due to missing asphalt. This break up is located at the junctures of the deck panels with the appearance of solar decomposition. The wearing surface is in fair condition. The wearing surface is cracking and breaking up over several of the joints exposing the top of the deck. During periods of hot weather the asphalt loses bond with the deck surface. This condition is visible in the form of large blisters.

BREAKUP OF DECK PANEL JOINT

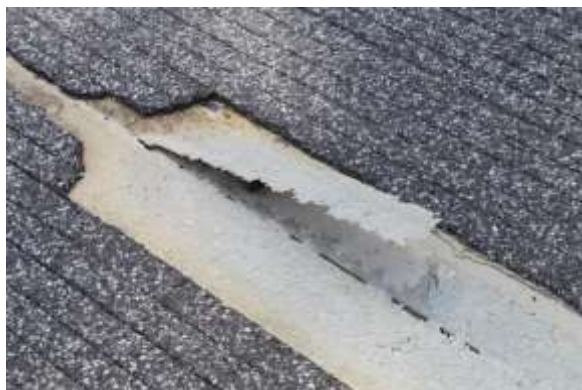
BREAK UP OF WEARING SURFACE AND DETERIORATION
OF DECK PANEL JOINT REINFORCEMENT

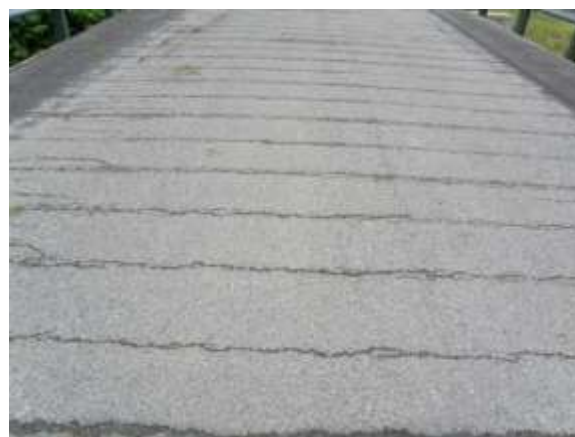
Current FRP Condition: The deck is in good condition with no defects. The wearing surface is in fair condition with transverse open cracks spaced approximately 18" across the entire deck with map cracking on the abutment #2 end of the structure. There is an area near the center of the roadway with missing asphalt and map cracking at abutment #2, 2'-0" in length, 6'-0" in width and averaging 2 inches in depth

TRANSVERSE CRACKS IN WEARING SURFACE

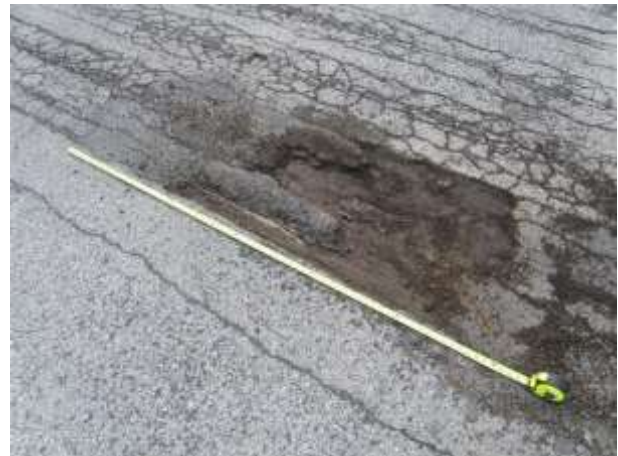
MISSING ASPHALT AT ABUTMENT 2

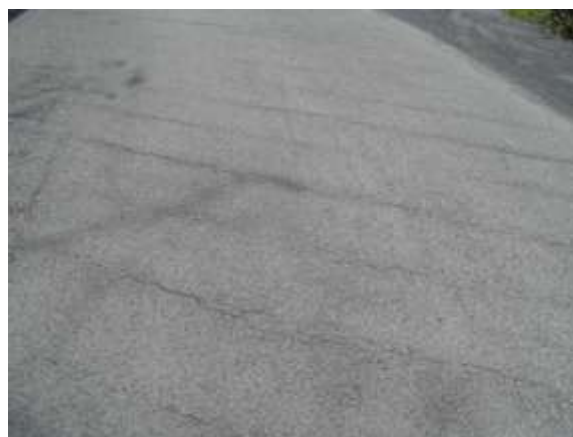
Current FRP Condition: The deck is in good condition with no significant defects. The wearing surface is in fair condition with several transverse cracks.

TRANSVERSE CRACKING IN WEARING SURFACE

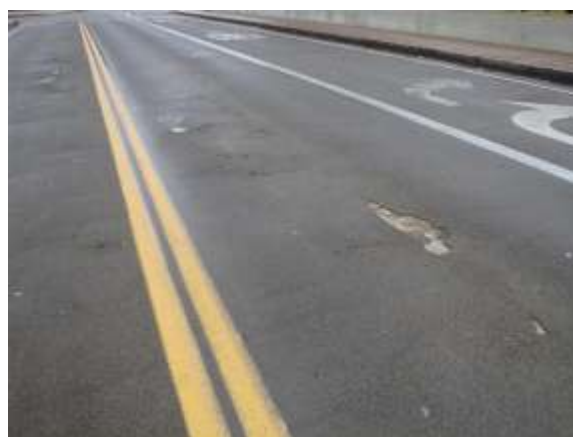
Current FRP Condition: The deck is still in good condition. There is efflorescence and moisture at the joints. The wearing surface is now in poor condition. The surface continues to display cracks, peeling granite, patchwork, and potholes exposing the FRP deck. This allows moisture to pass on to the superstructure. The sidewalks are now in fair condition. The polyurethane concrete with granite chips coating continues to display an increase in the cracks and deterioration the full length of the upstream and downstream walkways. The fiber glass joint material now displays poor adhesion and has lifted at random locations.

DELAMINATIONS IN WEARING SURFACE

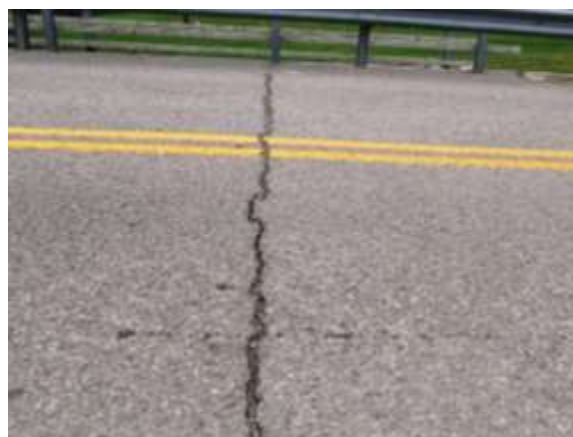
Current FRP Condition: The deck is in good condition. There were no deck clips broken or loose but there is deck movement under live load. The deck clips at Abutment 2 are bent due to over tightening. The wearing surface is in poor condition, due to cracks at all deck panel joints, with minor advancement since 2011. There is some minor leakage visible near Abutment 1. There are short longitudinal cracks at both abutments. The cracks are $\pm 1/16''$ to $5/16''$ wide. The sidewalk is in good condition.

WEARING SURFACE CRACK

Applicable Maintenance Issues: The original 3/8" thick epoxy wearing surface distintegrated following a very short service life. A new 2.25" (average) asphalt surface was applied in 2002.

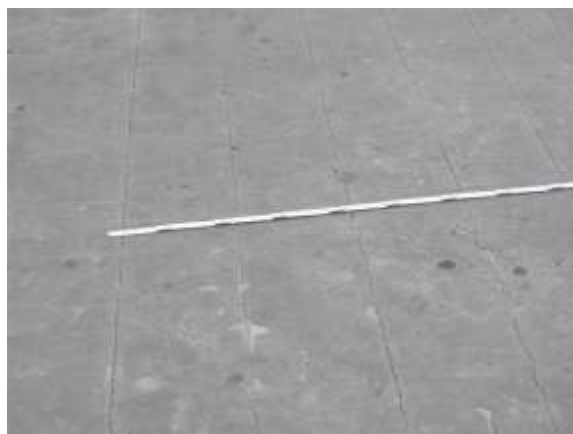
Current FRP Condition: The deck is in good condition. A few of the fasteners are loose. The wearing surface is in fair condition. Transverse cracks have developed in the wearing surface at the joints between the four pre-constructed deck panels. Corresponding cracks have developed in the concrete curbs. Cracks are also present over the joint between individual FRP planks and delaminations and map cracking exist. A few areas of missing wearing surface are also present. Water tends to stand on the deck near Abutment 2.

CRACKS IN WEARING SURFACE

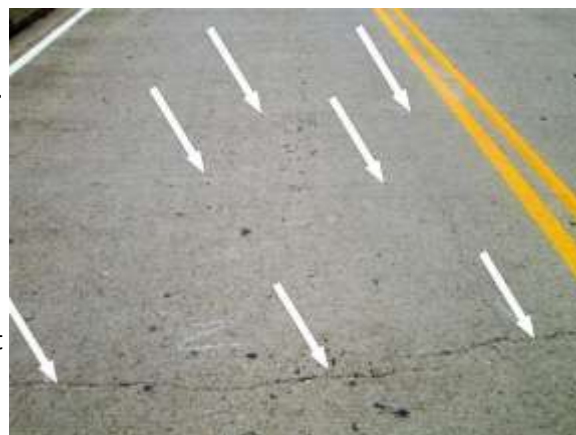
CRACKS IN THE WEARING SURFACE

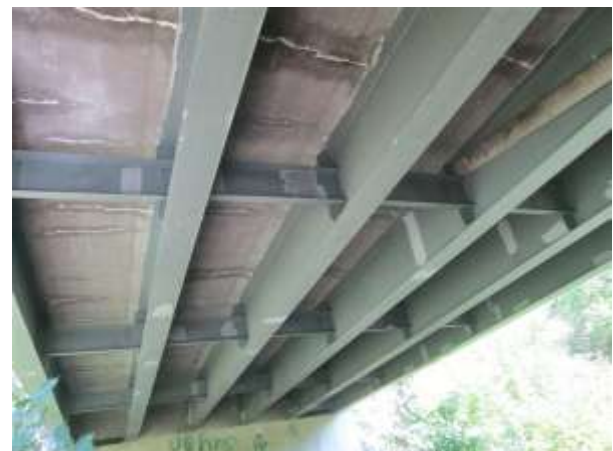
Current Deck Condition: The deck is in good condition. The underside continues to display numerous hairline transverse cracks with efflorescence stains in each span. There are small random isolated minor spalls in the deck haunches. The deck edge has random hairline cracks, there are transverse cracks with efflorescence in the overhangs. The textured concrete surface remains in good condition. There are still numerous hairline to 1/16" wide transverse, longitudinal and random cracks in each span. There are now small shallow edge spalls at the deck ends.

UNDERSIDE OF DECK WITH CRACKS/EFFLORESCENCE

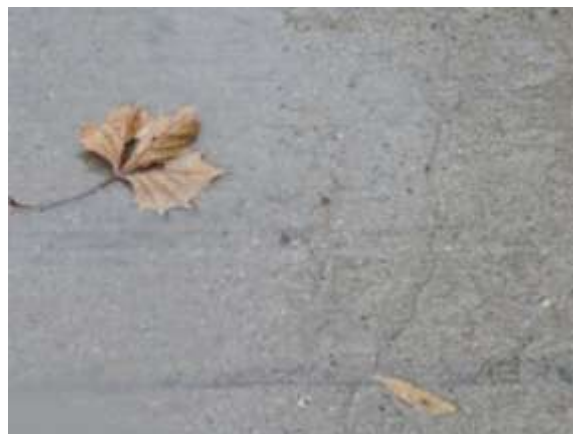
Current Deck Condition: The deck remains in fair condition. The top surface is slightly uneven due to the finishing technique. Hairline to 1/16" map cracking, with some water staining, is noted throughout the entire deck surface. The 2007 inspection observed "light cracking", while the 2009 inspection observed "an array of longitudinal hairline to 1/16" cracking in numerous areas". The inspectors believe the GFRP reinforced concrete deck is showing signs of advancing distress and should be dealt with accordingly. However, a relatively smooth ride is provided across the structure.

CRACKING IN DECK

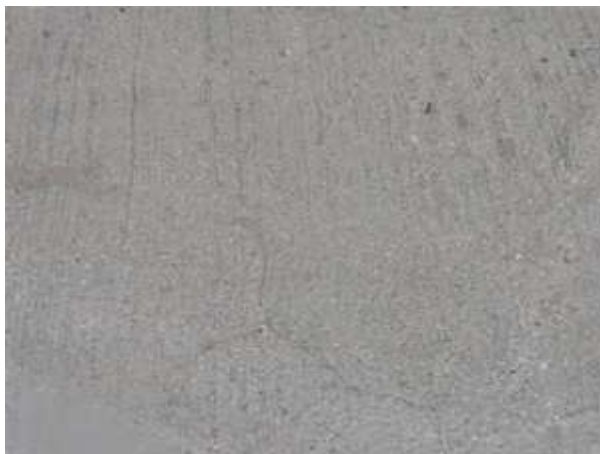
MAP CRACKING IN DECK

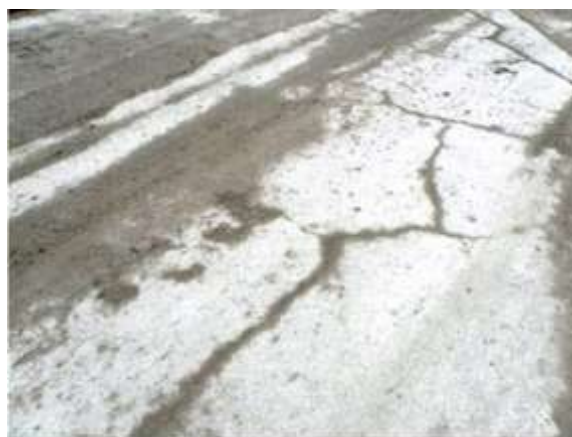
Current Deck Condition: The deck remains in fair condition, with hairline to 1/32" map cracking near Abutment One, longitudinal hairline to 1/32" cracking extending from the map cracking towards Abutment Two over Beam Four, a transverse/diagonal hairline crack over Beam Two at Abutment Two and exposed aggregate and a roughened deck surface in the wheel paths. A vertical hairline to 1/16" crack was also observed in the exterior upstream side just forward of the first guardrail post. Despite these deficiencies a relatively smooth ride is provided across the structure.

MAP CRACKING IN DECK

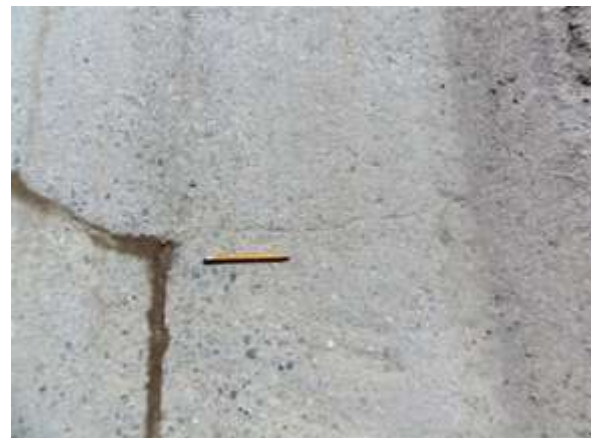
HAIRLINE CRACKS IN DECK

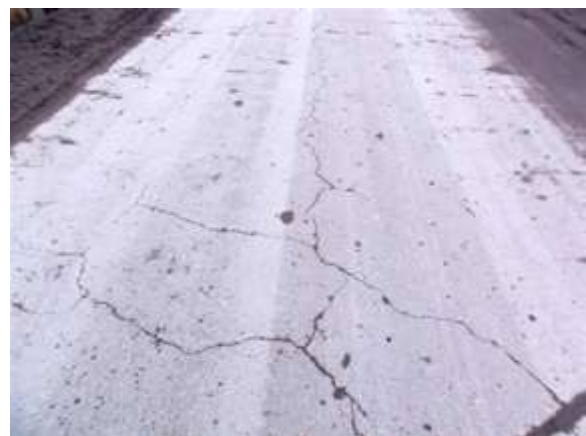
The deck remains in fair condition exhibiting the same map, diagonal, and longitudinal cracking as noted in 2009 and 2011 . Due to the staining between the beam undersides, we believe the 6" deck is leaking.

DECK CRACKING

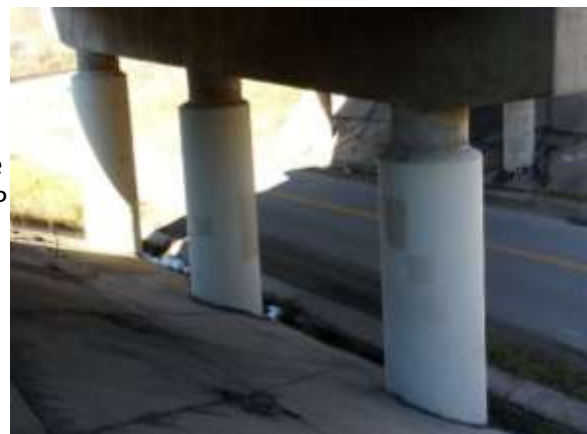
The FRP repairs remain in good condition.

COLUMNS WRAPPED WITH FRP

Applicable Maintenance Issues: The columns in Pier 1 were encased in concrete in 1990 to repair damage due to a fire. In 1998, these columns were repaired with FRP wraps and shells to provide confinement to the concrete to address cracking in the original repair. Three of the columns were repaired again in 2008 following another fire that damaged the 1998 FRP repair.

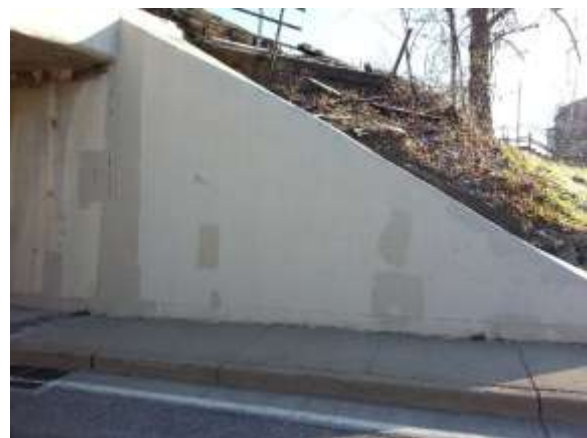
WINGWALL REPAIRED WITH FRP WRAPS

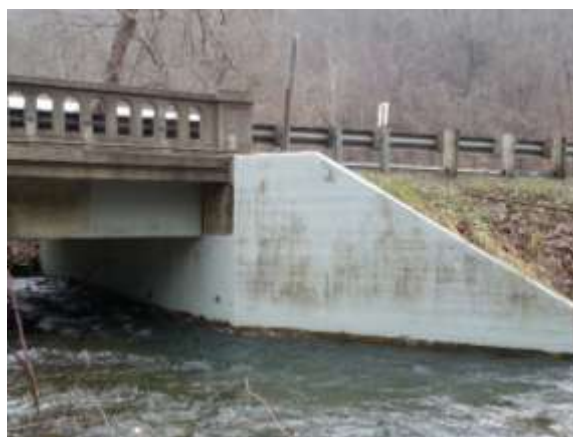
Current FRP Condition: The abutments are in fair condition. Minor spalling and scaling exists at the base of the breastwall and upstream wingwall beneath the carbon fiber wrap. There are a few localized spalls with exposed rebar in the backwall. The T-beams are in good condition.

FRP WRAP ON WINGWALL AND T-BEAM

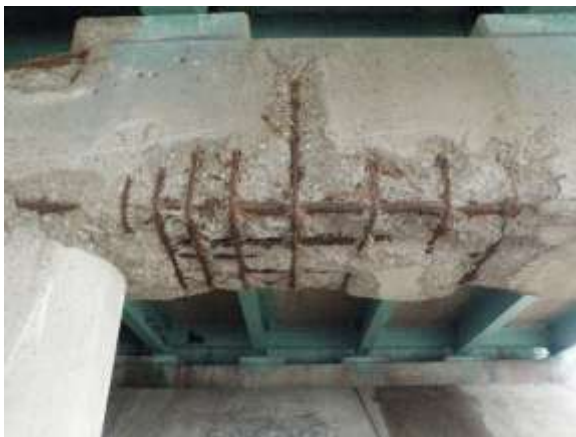
In 2014, FRP wraps used to rehabilitate piers 1 and 2 due to deterioration due to rebar corrosion leading to failure of concrete cover.

CONCRETE DETERIORATION PRIOR TO REPAIR

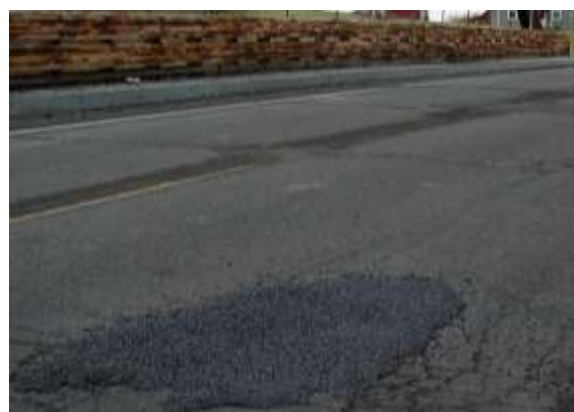
PATCHES IN WEARING SURFACE DUE TO FRP DECK FAILURE

Applicable Maintenance Issues: Steel plates were placed over failing deck panels in November 2006 and again in October 2007. FRP deck and sidewalk replaced in May 2009 with Exodermic deck.

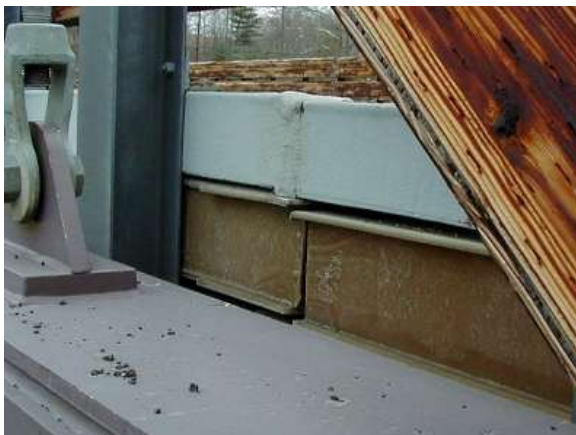
DISPLACEMENT OF FRP DECK

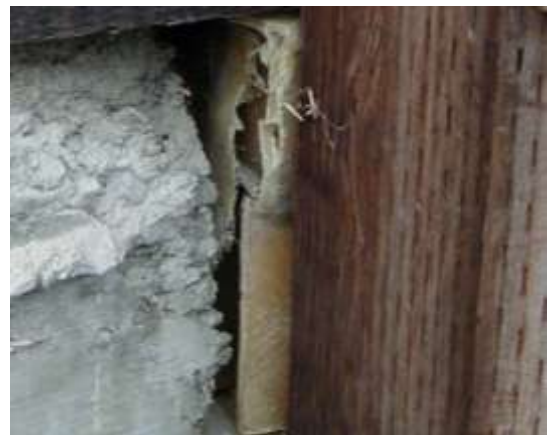
LOCALIZED FAILURE OF FRP DECK
