Fiber Reinforced Polymer (FRP) Composite Bridges in West Virginia

Hota GangaRao, PE
Mark Skidmore, PE
West Virginia University
Constructed Facilities Center
February 2017

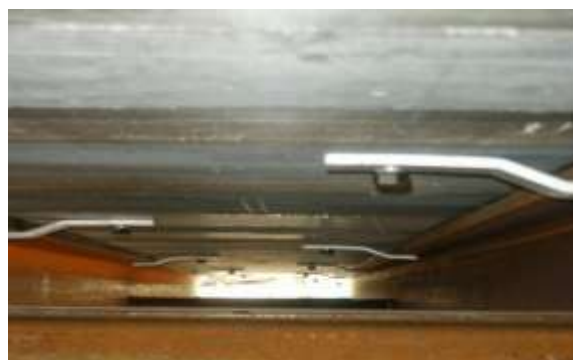
Z-CLIPS ATTACHING DECK TO BEAMS

Applicable Maintenance Issues: In 2010, state forces fastened the loose Z-clips, reinstalled the neoprene pads, and welded a keeper angle to hold the pads.

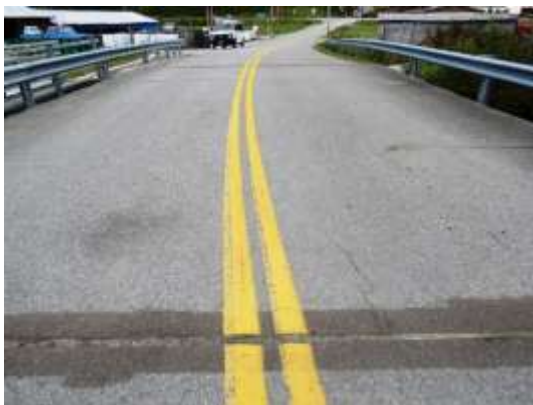
Current FRP Condition: The deck is in good condition. There were no deck clips broken or loose but there is deck movement under live load. The deck clips at Abutment 2 are bent due to over tightening. The wearing surface is in poor condition, due to cracks at all deck panel joints, with minor advancement since 2011. There is some minor leakage visible near Abutment 1. There are short longitudinal cracks at both abutments. The cracks are $\pm 1/16''$ to $5/16''$ wide. The sidewalk is in good condition.

WEARING SURFACE CONDITION

Applicable Maintenance Issues: The original 3/8" thick epoxy wearing surface distintegrated following a very short service life. A new 2.25" (average) asphalt surface was applied in 2002.

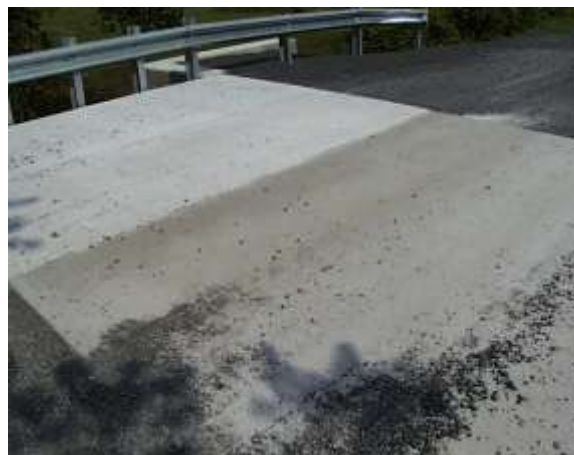
TOP OF SLAB

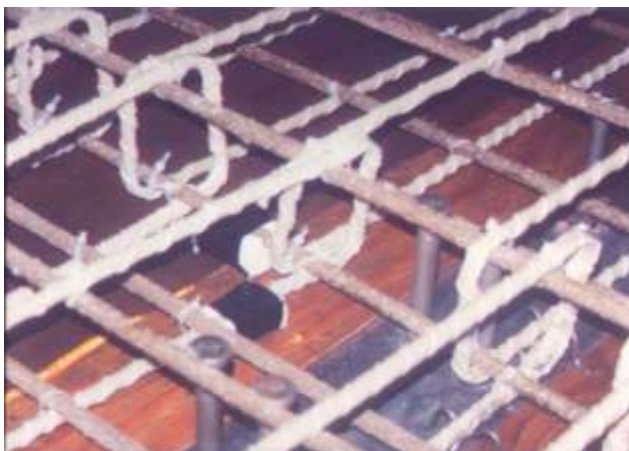
GFRP REINFORCEMENT IN DECK WITH STEEL SHEAR STUDS

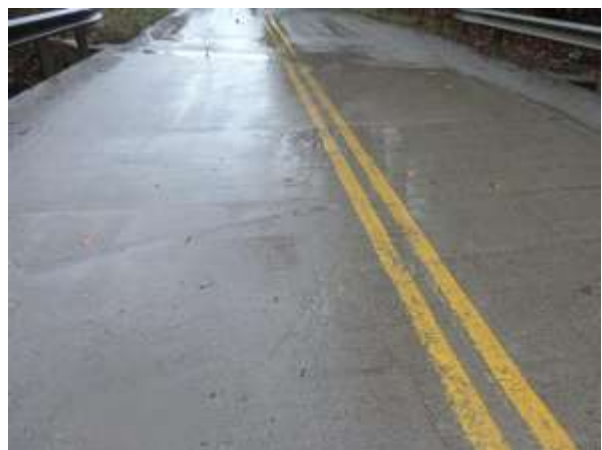
MAP CRACKING IN DECK

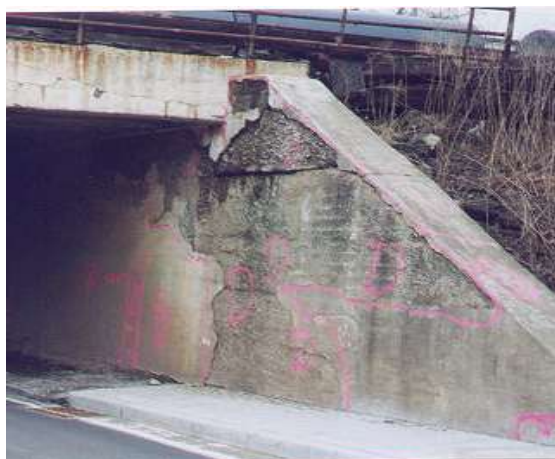
WINGWALL PRIOR TO REHABILITATION

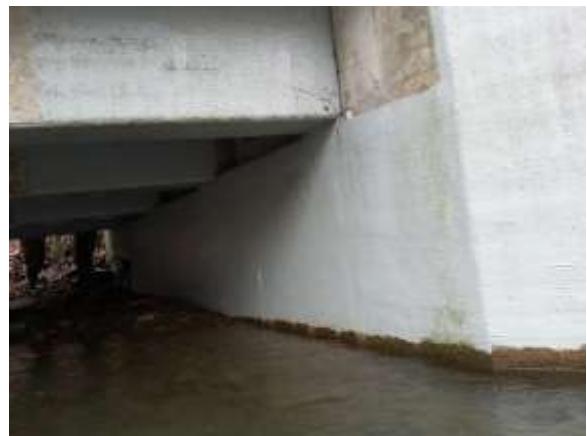
Current FRP Condition: The abutments are in fair condition. Minor spalling and scaling exists at the base of the breastwall and upstream wingwall beneath the carbon fiber wrap. There are a few localized spalls with exposed rebar in the backwall. The T-beams are in good condition.

FRP ON T-BEAM, ABUTMENT AND WINGWALL

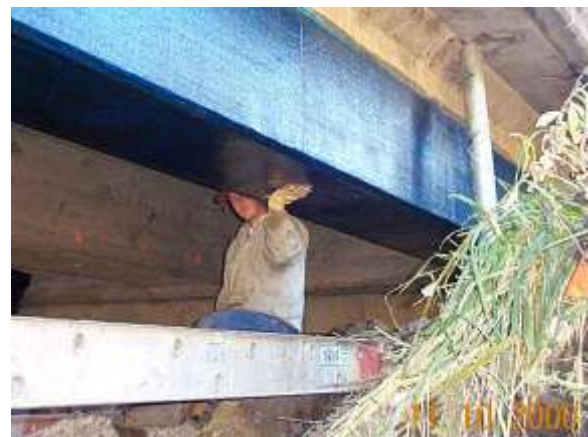
BLUE EPOXY WRAP PRIOR TO PAINTING

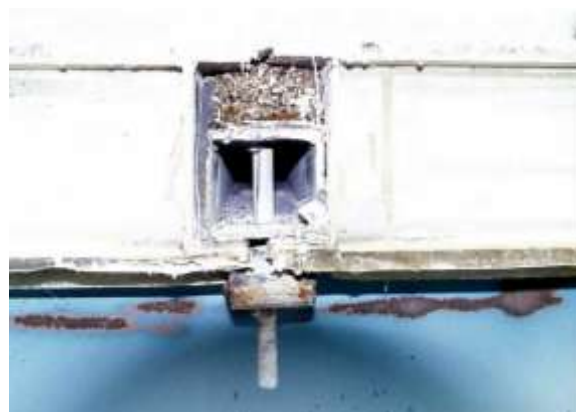
In June 2004, the District Eight Repair Crew straightened and tightened numerous loose deck clips. Additional shims were installed between the deck underside and the top flanges of the stringers. A steel plate was installed in over the failed deck panel in the downstream lane near Abutment 1.

DECK TO STRINGER CONNECTOR

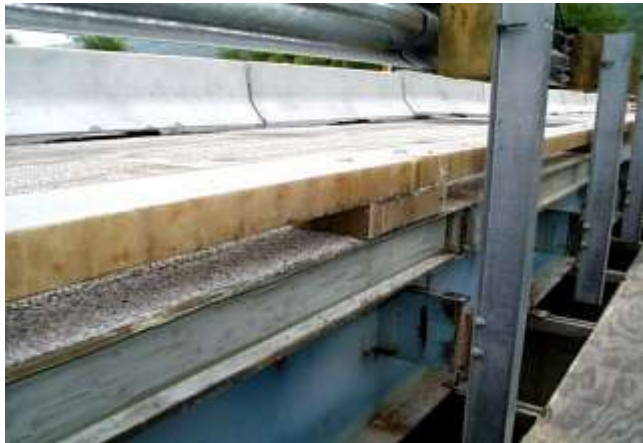
FRP DECK AND CURB

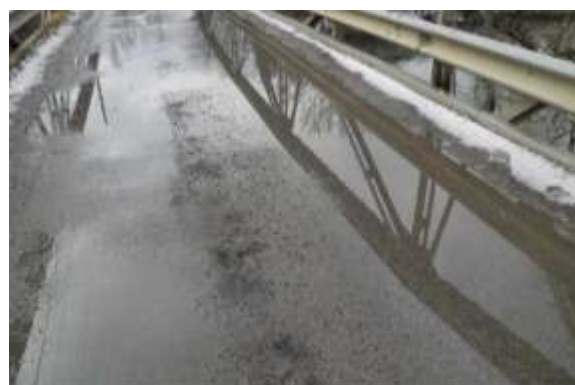
Current FRP Condition: The deck is in good condition. Water pools on the deck due to low spots in the FRP deck. The wearing surface is in good condition, with the only deficiency observed was the existence of transverse, hairline cracks over all the floorbeams.

WATER STANDING ON DECK

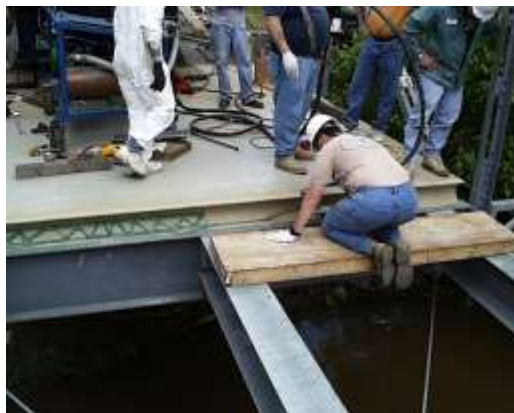
PLIOGRIP FOR DECK TO DECK CONNECTION

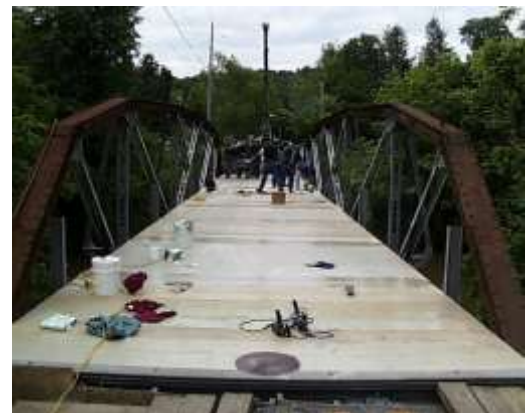
DECK PRIOR TO WEARING SURFACE INSTALLATION

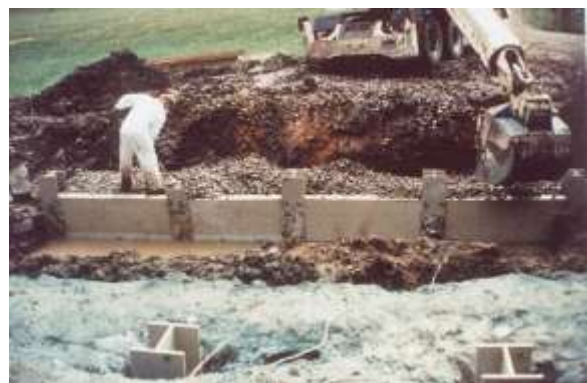
GFRP PILES/CELLULAR LAGGING MODULES

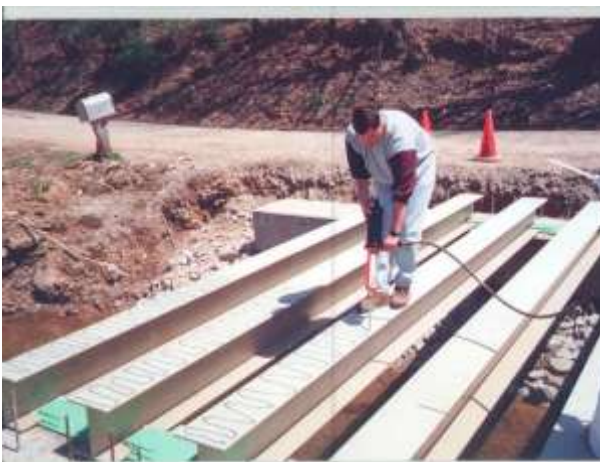
APPLICATION OF PLIOGRIP ADHESIVE TO GFRP BEAMS

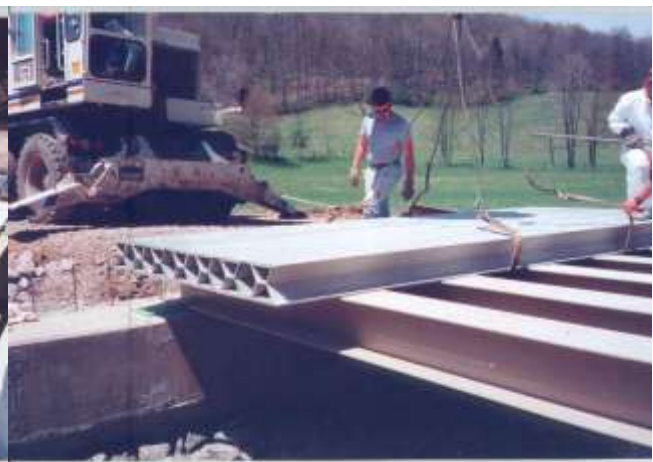
INSTALLATION OF DECK PANELS
